Reserve Analysis Report

Windemere Court HOA

3950 Cleveland Ave San Diego, CA 92103

For Fiscal Year End: February 28, 2009

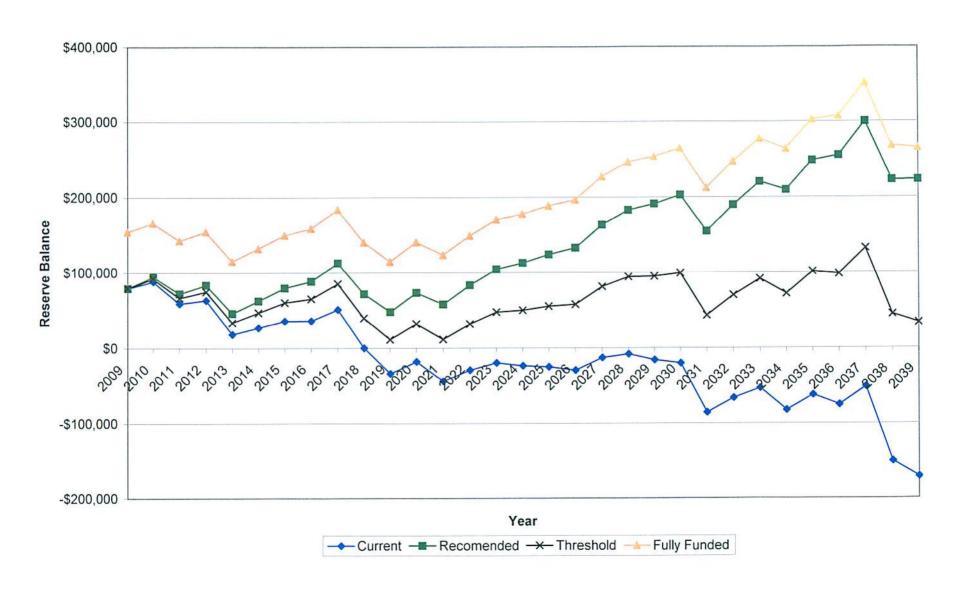
30 Year Reserve Balance Projection

30 Year Reserve Projection Graph – Displays the reserve account balance for the current, fully funded, threshold, and recommended funding plans over the next 30 years. (Inflation and annual dues increase are taken into account)

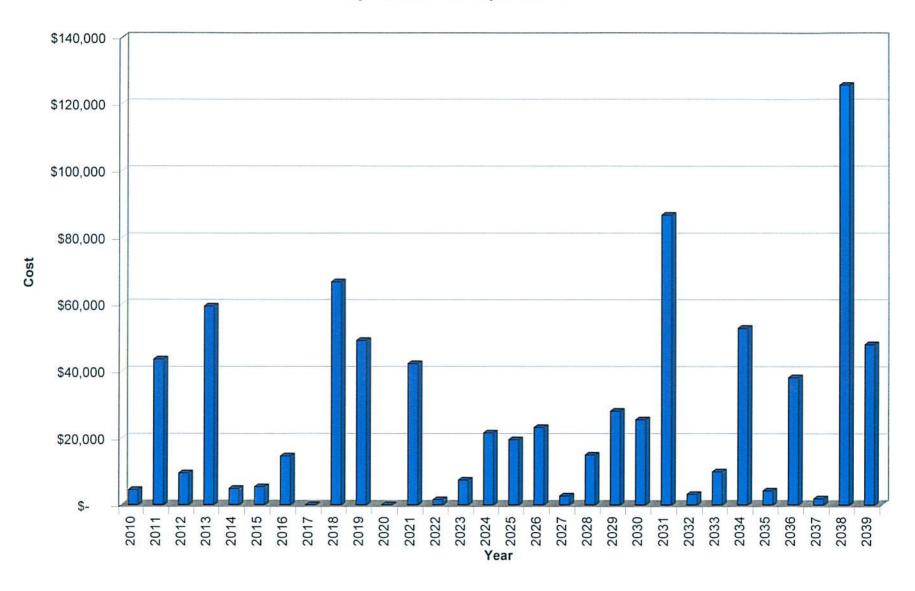
Projected Annual Expenditures

Projected Annual Expenses Graph – Displays projected annual expenses over the next 30 years in a bar graph. (Inflation is taken into account)

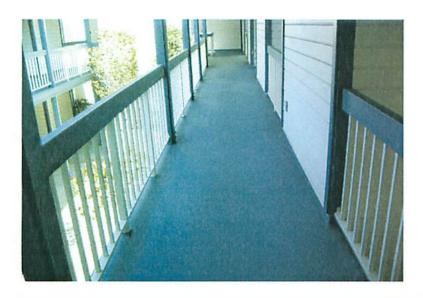
Roofing/Decking				Upper Walkway	Recoat
Approximate Component Quantity	-	2950	Estimated Current Unit Cost	\$	1.70
Unit of Measure	-	SF	Estimated Total Current Cost	\$	5,015
Normal Useful Life (Years)		5	Estimated Total Future Cost	S	5,480
Estimated Remaining Useful Life (Years)	-	3	Fully Funded Balance	S	2,006
Estimated Replacement Year	-	2012	Depreciation This Year	S	1,003
Cost Source	-	1	Market Annual Committee of the Committee

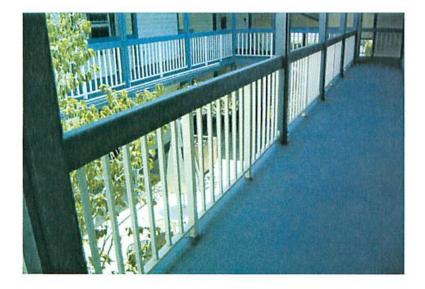
Fencing/Rails				Courtyard I	Rail Repairs
Approximate Component Quantity		1	Estimated Current Unit Cost	\$	2,000.00
Unit of Measure	-	Allowance	Estimated Total Current Cost	S	2,000
Normal Useful Life (Years)		10	Estimated Total Future Cost	\$	2,319
Estimated Remaining Useful Life (Years)	-	5	Fully Funded Balance	S	1,000
Estimated Replacement Year		2014	Depreciation This Year	S	200
Cost Source		1	The second secon

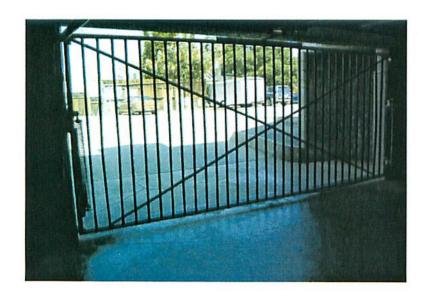
Fencing/Rails				١	ehicle Gate
Approximate Component Quantity	-	1	Estimated Current Unit Cost	\$	2,500.00
Unit of Measure	-	Each	Estimated Total Current Cost	\$	2,500
Normal Useful Life (Years)	-	25	Estimated Total Future Cost	S	2.732
Estimated Remaining Useful Life (Years)	-	3	Fully Funded Balance	S	2,200
Estimated Replacement Year		2012	Depreciation This Year	S	100
Cost Source		1	White and Complete Committee of the Comm	54 7 (1)	1 1000

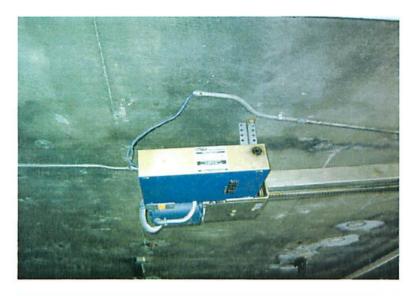
Vehicle Ga	te Operator
-	1	Estimated Current Unit Cost	\$	2,600.00
-	Each	Estimated Total Current Cost	\$	2,600
-	15	Estimated Total Future Cost	\$	3,014
-	5	Fully Funded Balance	\$	1,733
	2014	Depreciation This Year	\$	173
•	1			
		- Each - 15 - 5 - 2014	 Each 15 Estimated Total Current Cost Estimated Total Future Cost Fully Funded Balance 2014 Depreciation This Year 	- 1 Estimated Current Unit Cost \$ - Each Estimated Total Current Cost \$ - 15 Estimated Total Future Cost \$ - 5 Fully Funded Balance \$ - 2014 Depreciation This Year \$

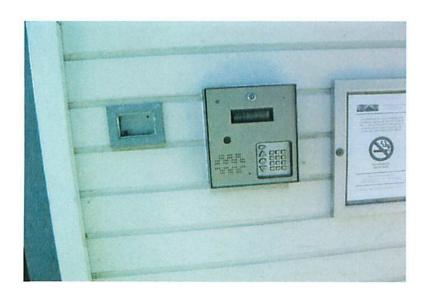
Fencing/Rails				Ent	ry Intercom
Approximate Component Quantity	-	1	Estimated Current Unit Cost	\$	2,500.00
Unit of Measure	-	Each	Estimated Total Current Cost	\$	2,500
Normal Useful Life (Years)	-	15	Estimated Total Future Cost	\$	3,781
Estimated Remaining Useful Life (Years)		14	Fully Funded Balance	\$	167
Estimated Replacement Year	-2	2023	Depreciation This Year	\$	167
Cost Source		1	Service Control Control Service Supplied Control Contr	45///	UNDER!

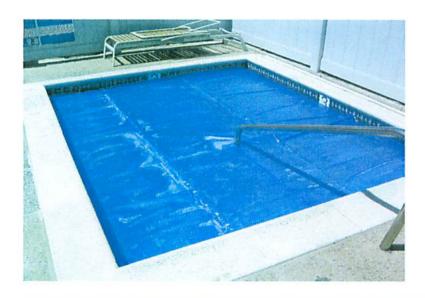
Spa Area				Sp	a Resurface
Approximate Component Quantity	-	1	Estimated Current Unit Cost	S	3,400.00
Unit of Measure	- 2	Allowance	Estimated Total Current Cost	\$	3,400
Normal Useful Life (Years)	-	12	Estimated Total Future Cost	\$	3,607
Estimated Remaining Useful Life (Years)	-	2	Fully Funded Balance	\$	2,833
Estimated Replacement Year	7.7	2011	Depreciation This Year	\$	283
Cost Source	-	1	Service and the service and th

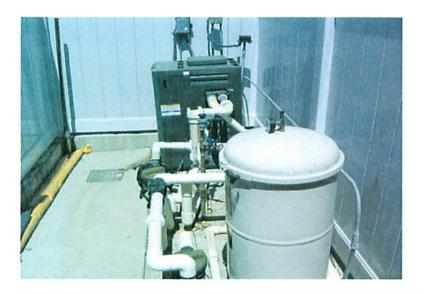
Spa Area					Spa Filter
Approximate Component Quantity	-	1	Estimated Current Unit Cost	s	1,100.00
Unit of Measure		Each	Estimated Total Current Cost	\$	1,100
Normal Useful Life (Years)		10	Estimated Total Future Cost	\$	1,167
Estimated Remaining Useful Life (Years)		2	Fully Funded Balance	S	880
Estimated Replacement Year	-	2011	Depreciation This Year	S	110
Cost Source		1

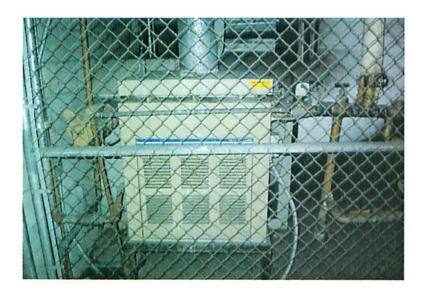
Mechanical/Plumbing				Hot V	Vater Heater
Approximate Component Quantity	5. - 6.5	1	Estimated Current Unit Cost	s	4,500.00
Unit of Measure	12	Each	Estimated Total Current Cost	\$	4,500
Normal Useful Life (Years)		20	Estimated Total Future Cost	S	4,500
Estimated Remaining Useful Life (Years)	-	0	Fully Funded Balance	S	4,500
Estimated Replacement Year	-	2009	Depreciation This Year	S	225
Cost Source	-	1	and and a contraction of the contraction of the contraction

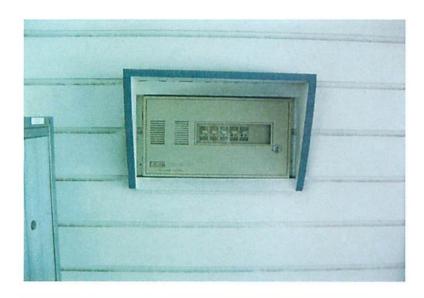
Mechanical/Plumbing			F	ire Alarm Co	ntrol Panel
Approximate Component Quantity	-	1	Estimated Current Unit Cost	\$	1,500.00
Unit of Measure		Each	Estimated Total Current Cost	\$	1,500
Normal Useful Life (Years)	-	20	Estimated Total Future Cost	S	1.545
Estimated Remaining Useful Life (Years)	-	1	Fully Funded Balance	\$	1,425
Estimated Replacement Year		2010	Depreciation This Year	\$	75
Cost Source	-	1	Smith 1 € North State (1997) 100

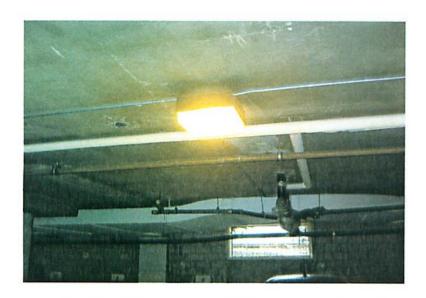
Lighting				Ceiling Mounted	Garage
Approximate Component Quantity	-	9	Estimated Current Unit Cost	\$	120.00
Unit of Measure		Each	Estimated Total Current Cost	\$	1.080
Normal Useful Life (Years)		20	Estimated Total Future Cost	S	1,112
Estimated Remaining Useful Life (Years)	-	1	Fully Funded Balance	S	1,026
Estimated Replacement Year	-	2010	Depreciation This Year	S	54
Cost Source		1	INSTANCE → STOCKE STOCKE SHOW SHOWS A CONTRACT OF SHOWS

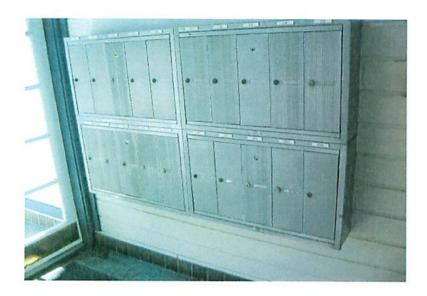
Miscellaneous					Mailboxes
Approximate Component Quantity		30	Estimated Current Unit Cost	s	60.00
Unit of Measure	-	Each	Estimated Total Current Cost	S	1,800
Normal Useful Life (Years)	-	25	Estimated Total Future Cost	S	1,967
Estimated Remaining Useful Life (Years)		3	Fully Funded Balance	S	1,584
Estimated Replacement Year	-	2012	Depreciation This Year	S	72
Cost Source	-	1	SAN DE CONTRACTO DE LA SISTEMA DE LA CONTRACTOR DE CONTRAC
